Presented to: Redford Union School District

March 13, 2023

TRACK SURFACE DEPRESSIONS

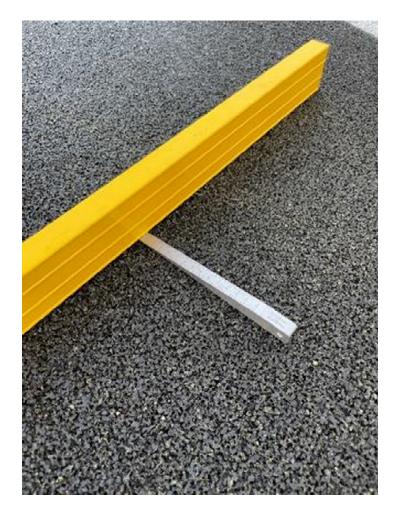
A site walk was performed on 10-21-2022 to review the track surface. During this meeting a one-meter aluminum level was used to span across noted depressions (as seen in the photos here). A thin calibrated wedge was used to measure the depth of noted depressions in the track surface.

- 8-10 different depressions observed were measured.
- One area noted in the 10-31-2022 field report having a depth greater than 5mm but no greater than 9mm. This area as noted is scheduled for repair work in 2023.
- Several other depressions were measured with depths ranging from 1mm to 3mm across the 1 meter straightedge.

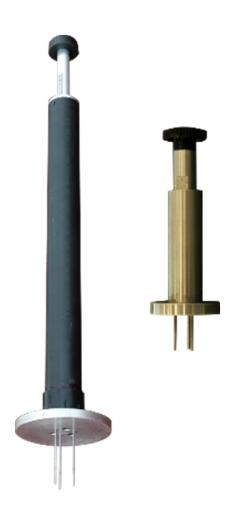
PMC organized additional on-site samplings of the Redford Track at Hilbert. 96 additional depths were sampled using the Floor-Test FT150 tool on 02/10/2023. Members of French Associates and Foresite Design were present to conduct this test.

- Track depths were recorded at sixty-foot intervals around the track (total of 96 samples were recorded).
- The average surface depth based on the 96 samples is 14.75mm.
- No depths were measured less than 10mm.

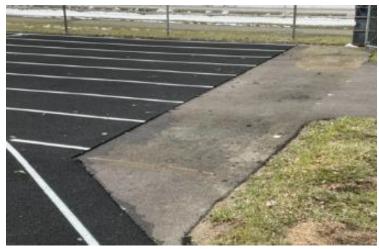
Redford Union

Varied Edge Conditions
